**AFML-TR-78-108**

**DEFINITION AND NON-DESTRUCTIVE  
DETECTION OF CRITICAL ADHESIVE  
BOND-LINE FLAWS**

MCDONNELL AIRCRAFT COMPANY  
MCDONNELL DOUGLAS CORPORATION  
P.O. BOX 516  
ST. LOUIS, MISSOURI 63166

TECHNICAL REPORT AFML-TR-78-108  
FINAL REPORT FOR PERIOD  
27 JUNE 1975 - 31 JULY 1978

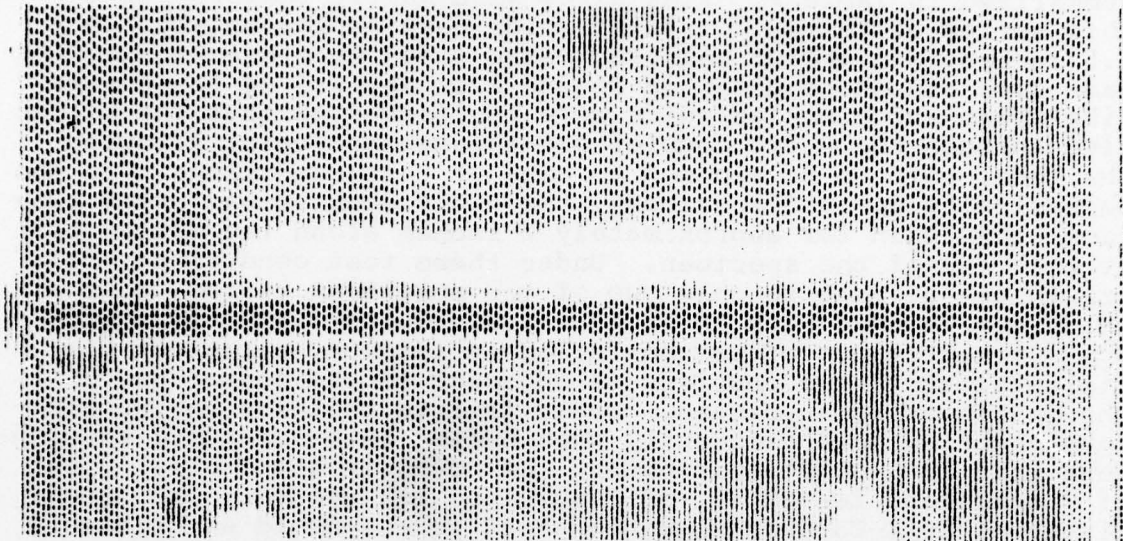
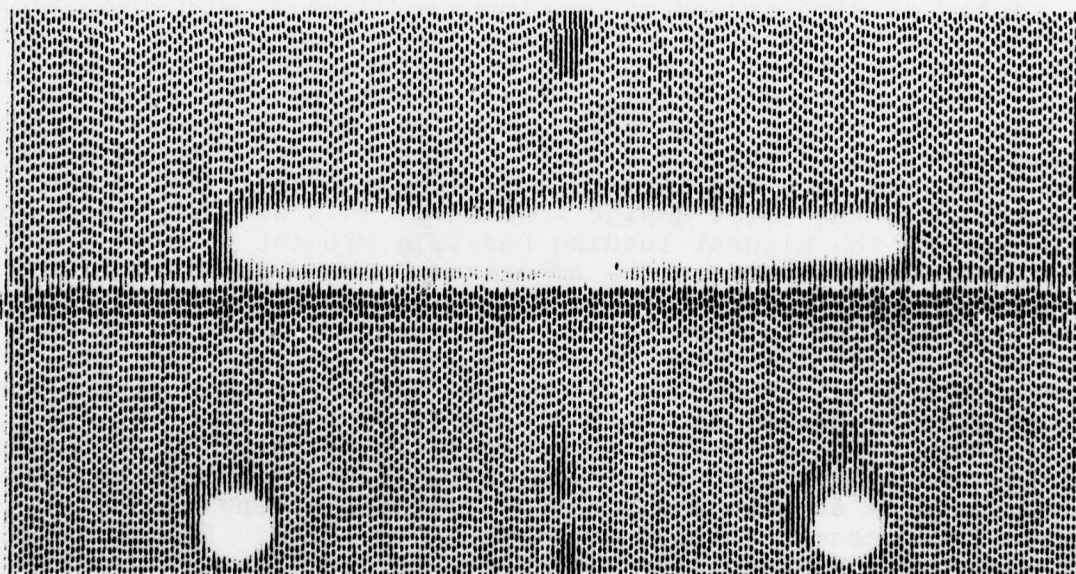
(a) C-Scan Before Cycling

(b) C-Scan After 10<sup>6</sup> Cycles

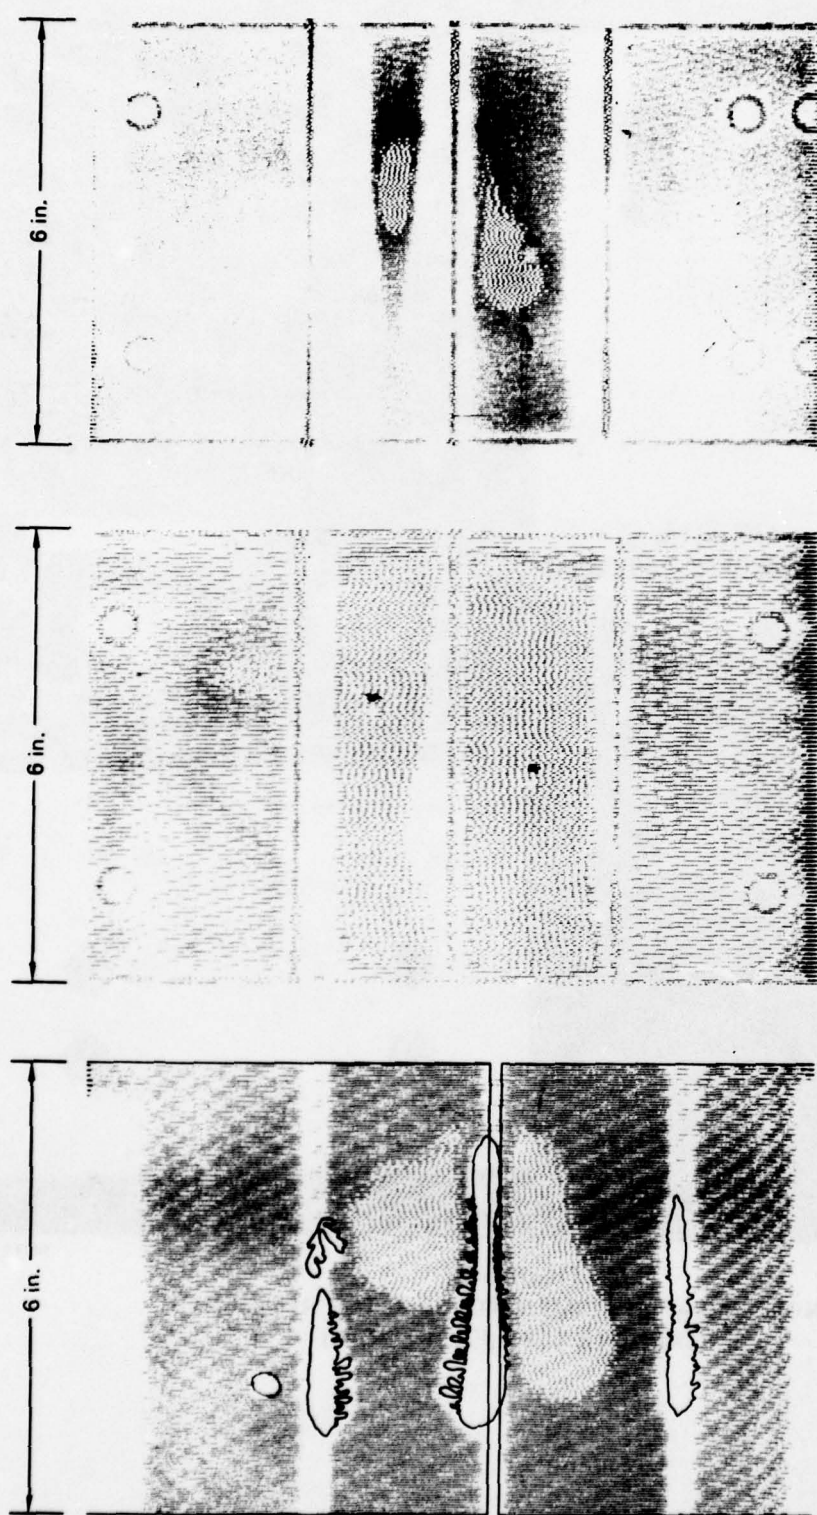
**FIGURE 24**  
**C-SCANS OF SINGLE-STRAP SPECIMEN NO. 5**

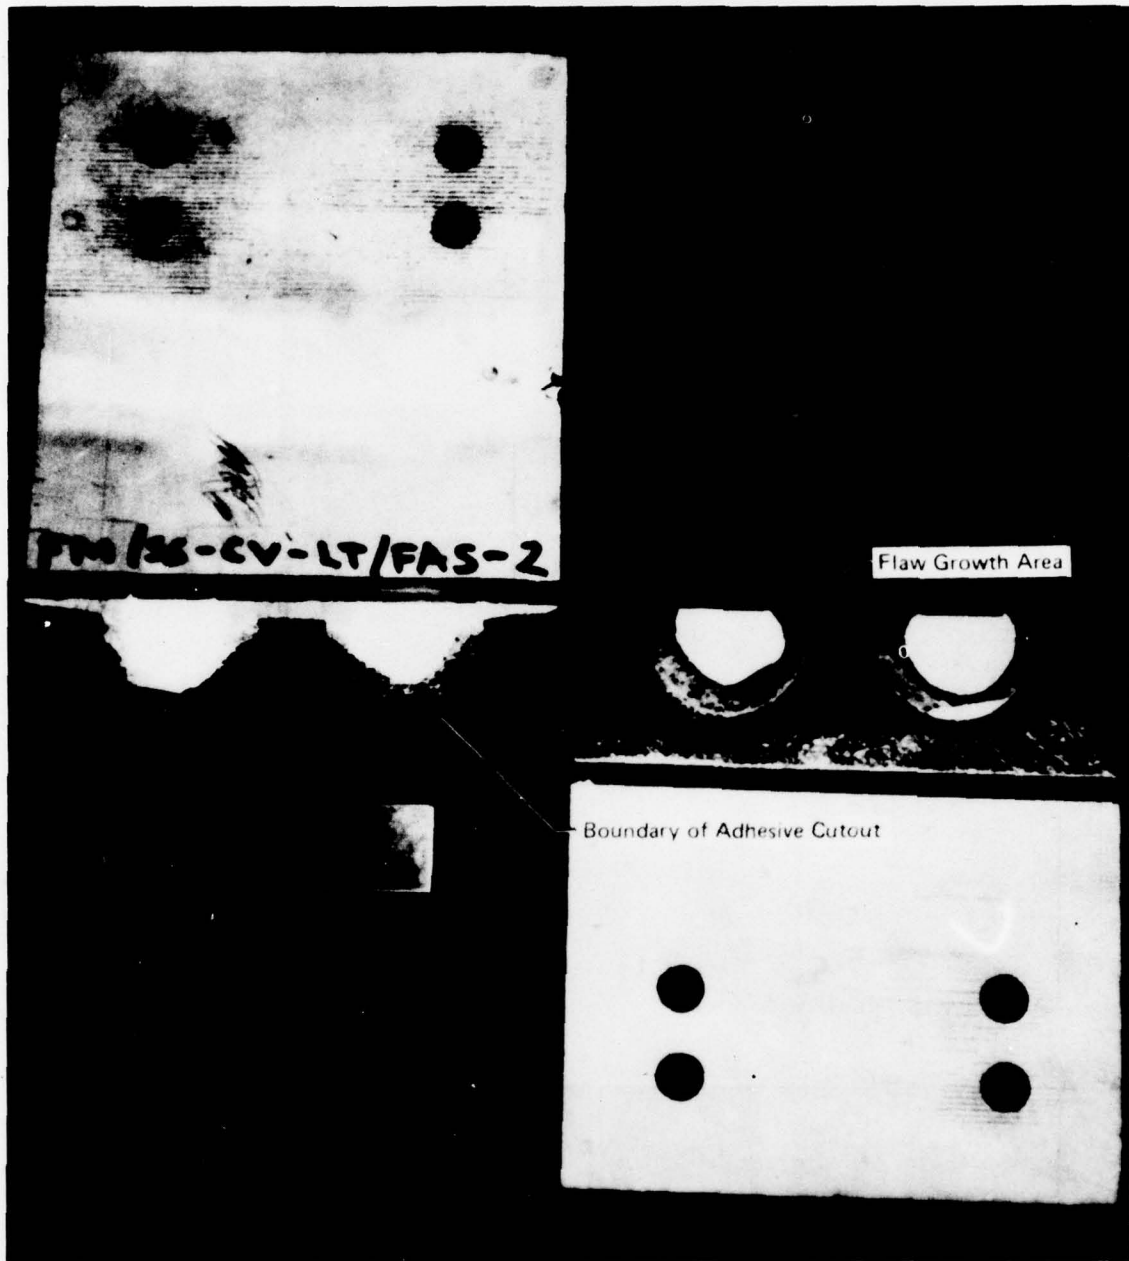
**FIGURE 25**  
**SINGLE-STRAP SPECIMEN NO. 32 AFTER RESIDUAL**  
**STRENGTH TEST (FAST CYCLE)**

Visual inspection of specimens after residual strength tests, using a 10-30X variable power viewer, revealed that flaw growth always initiated on the surface of the terminating adherend at the edges of the machined grooves as shown in Figure 26. It then propagated to and along the adhesive-primer interface of the continuing adherend. This failed surface is described as a combined adhesive-cohesive failure because small pieces of adhesive (visible only with the viewer) remained bonded to the primer. Static overloads after cycling caused the remaining adhesive to fail cohesively, i.e., totally within the adhesive.

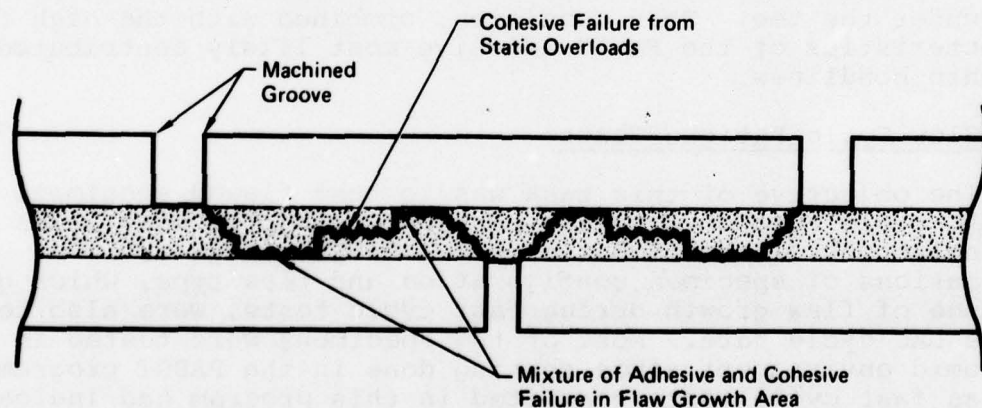
**FIGURE 26**  
**FLAW GROWTH CHARACTERISTICS OF SINGLE-STRAP SPECIMENS**

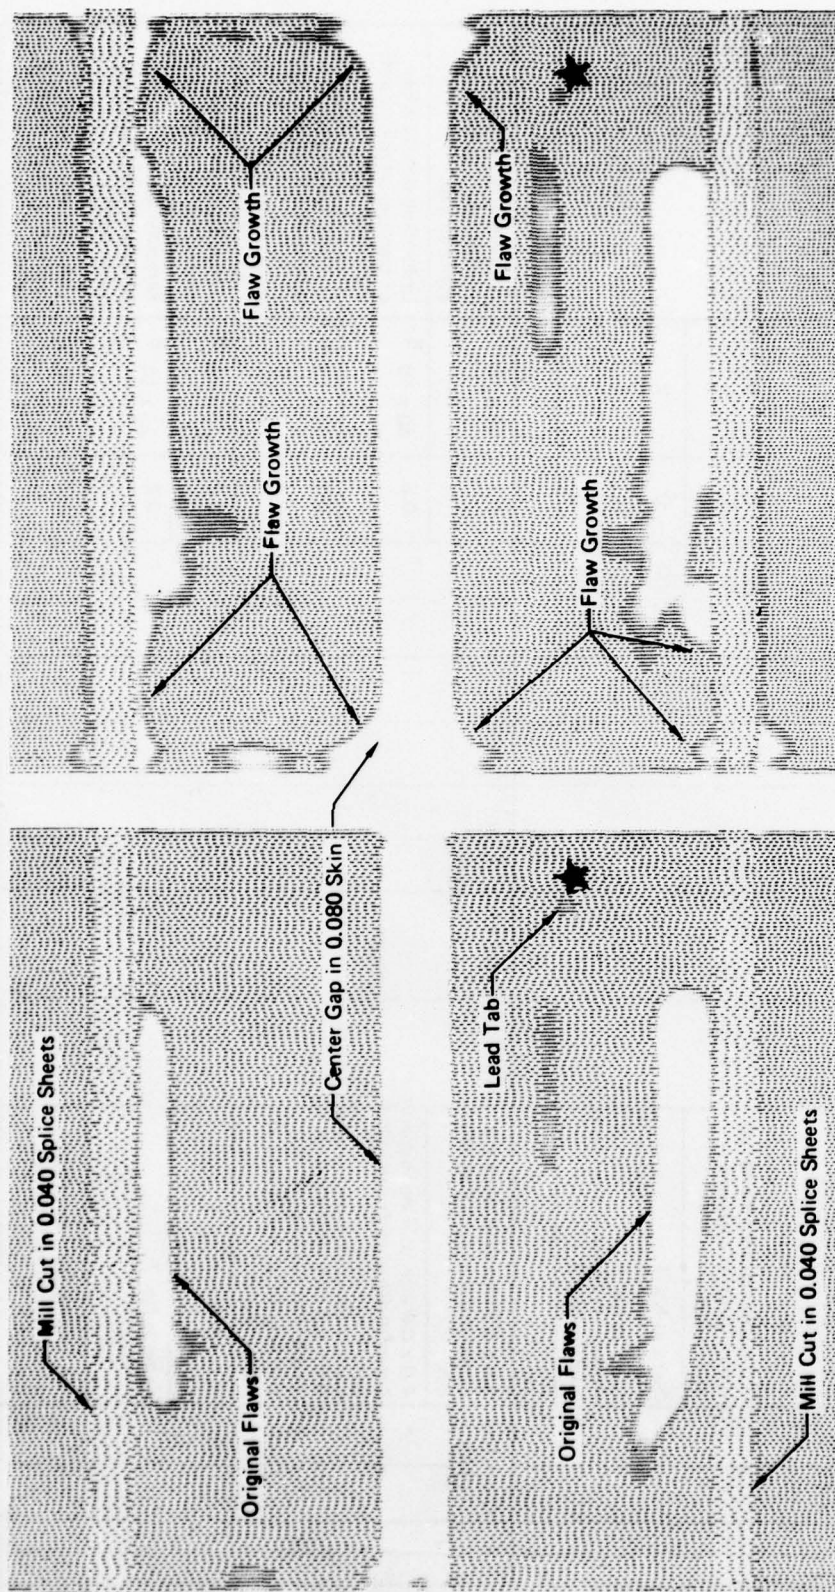
**FIGURE 27**  
**C-SCANS OF DOUBLE-STRAP SPECIMEN NO. 7 BEFORE AND AFTER CYCLING**
